June 28, 2019
File No. 262018.063

Subject: Department of Natural Resources Washington Geological Survey,
School Seismic Safety Assessment Project, Contract No. AE 410 -
Seismic Evaluation for **Port Townsend School District**

School Buildings Evaluated in the Port Townsend School District

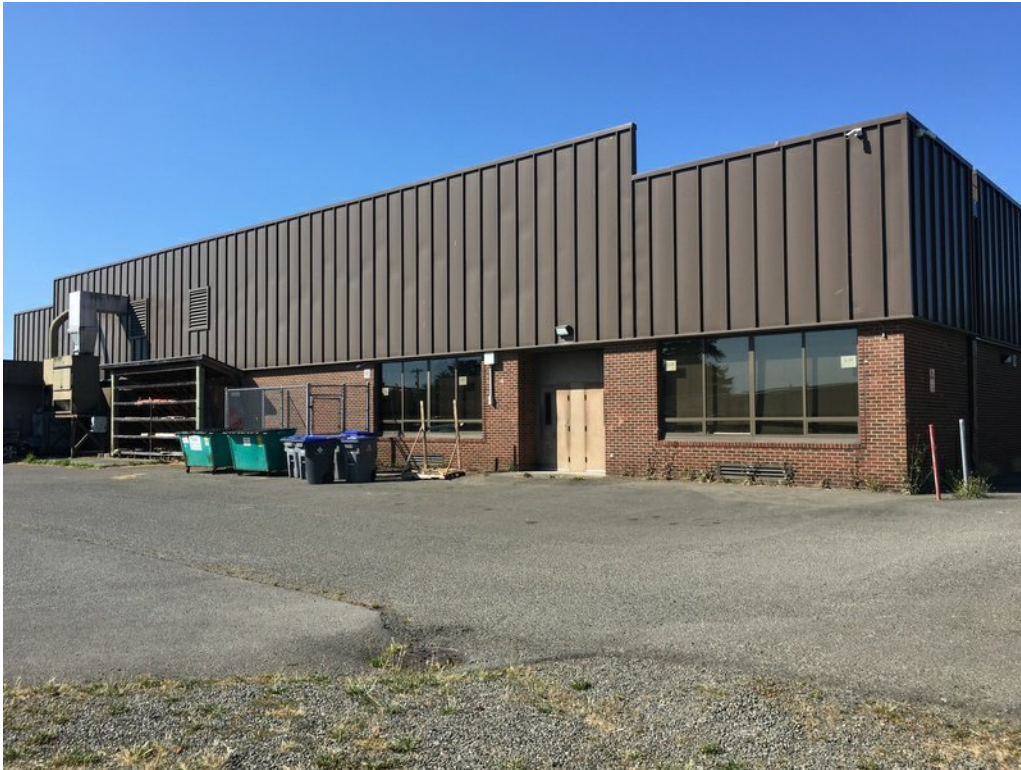
Figure 1-1. Gym/Shop Building, North Elevation

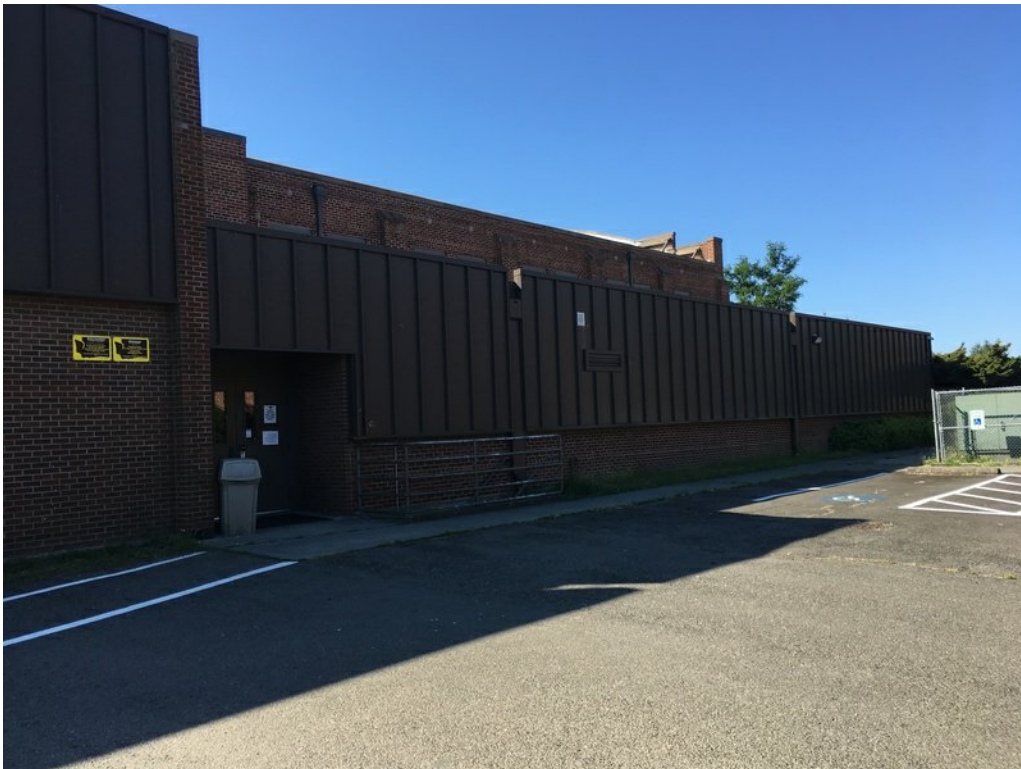
Figure 1-2. Gym/Shop Building, North Elevation

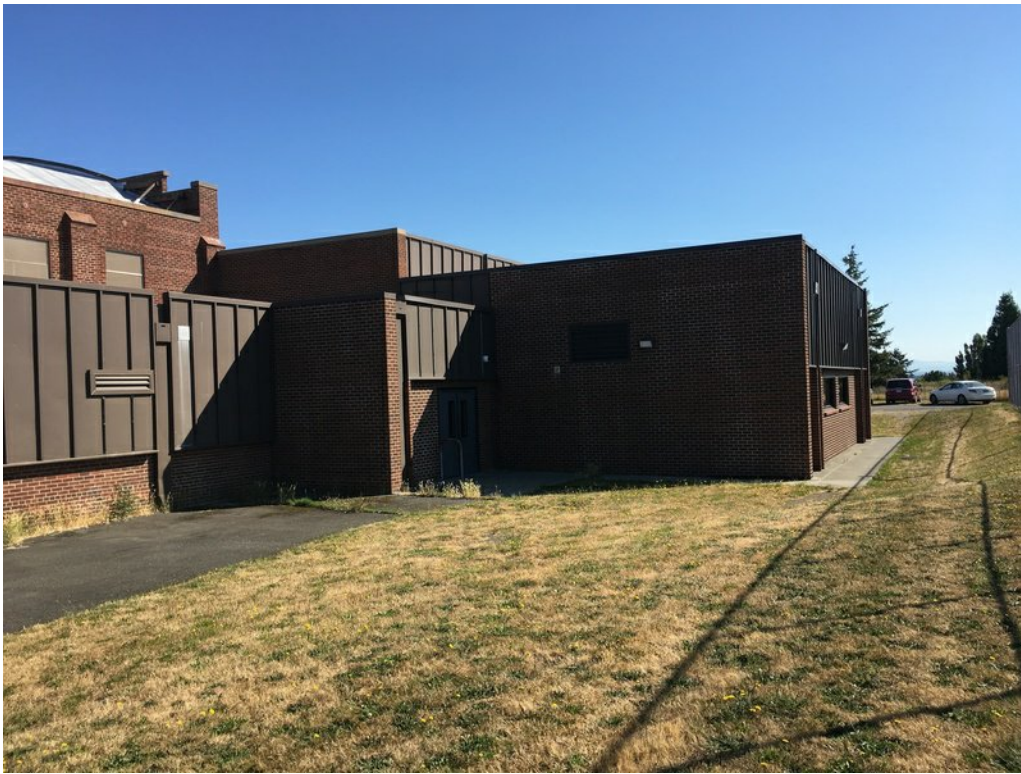
Figure 1-3. Gym/Shop Building, South Elevation

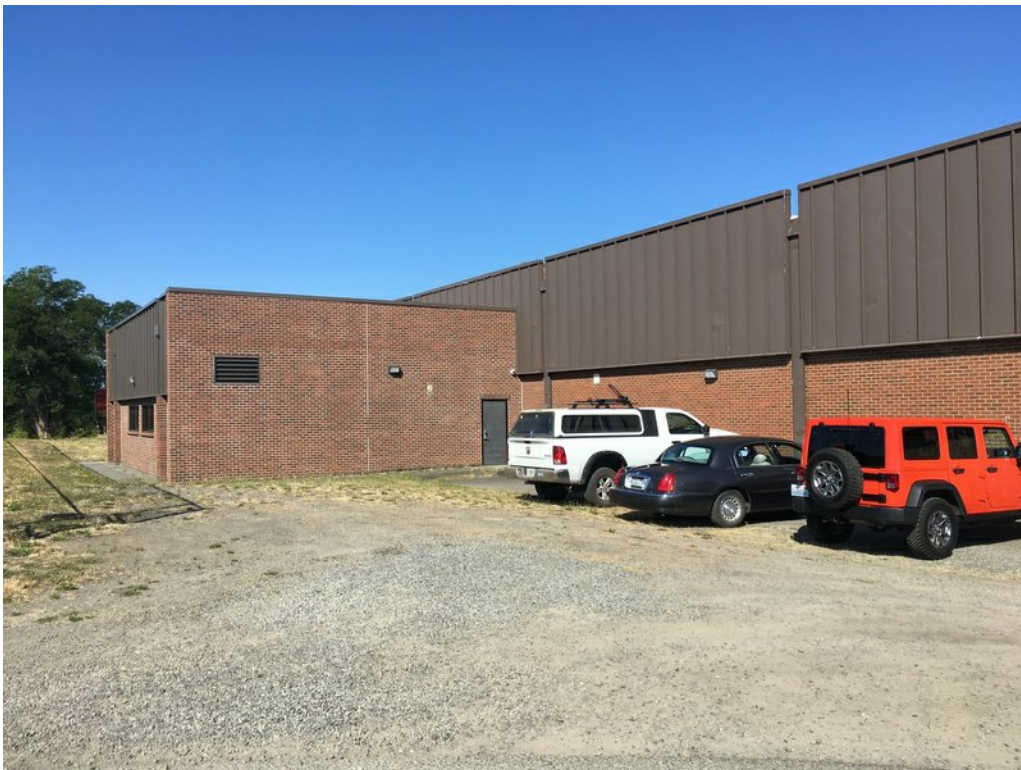
Figure 1-4. Gym/Shop Building, South Elevation

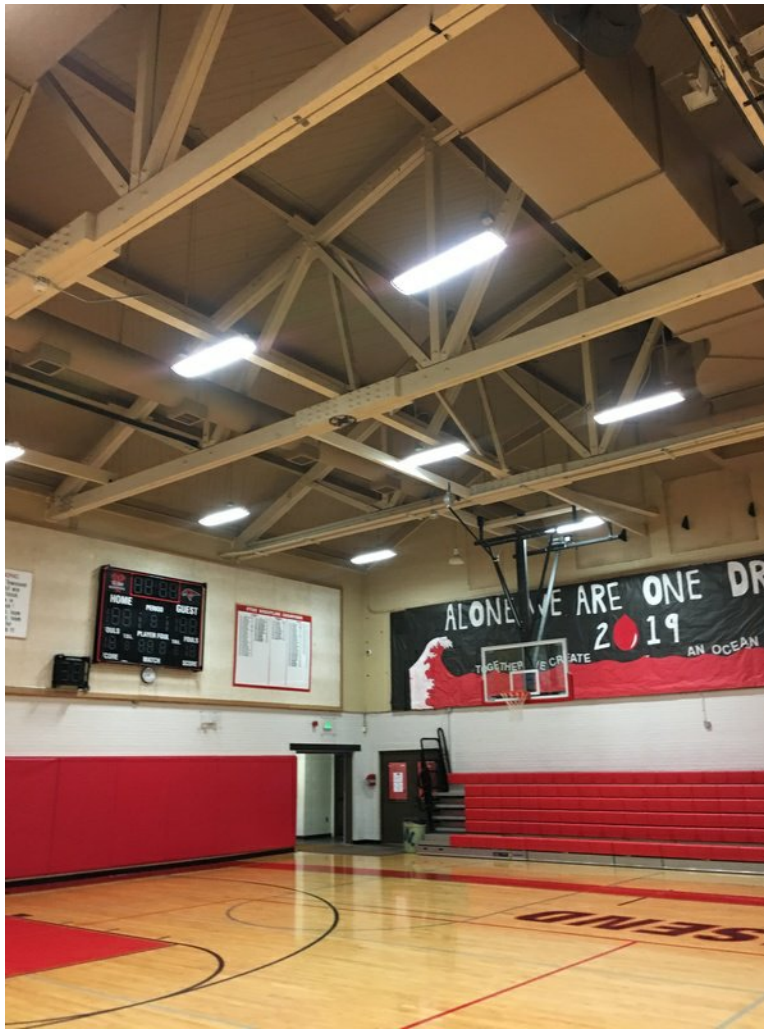
Figure 1-5. Gym/Shop Building, Typical Roof Framing

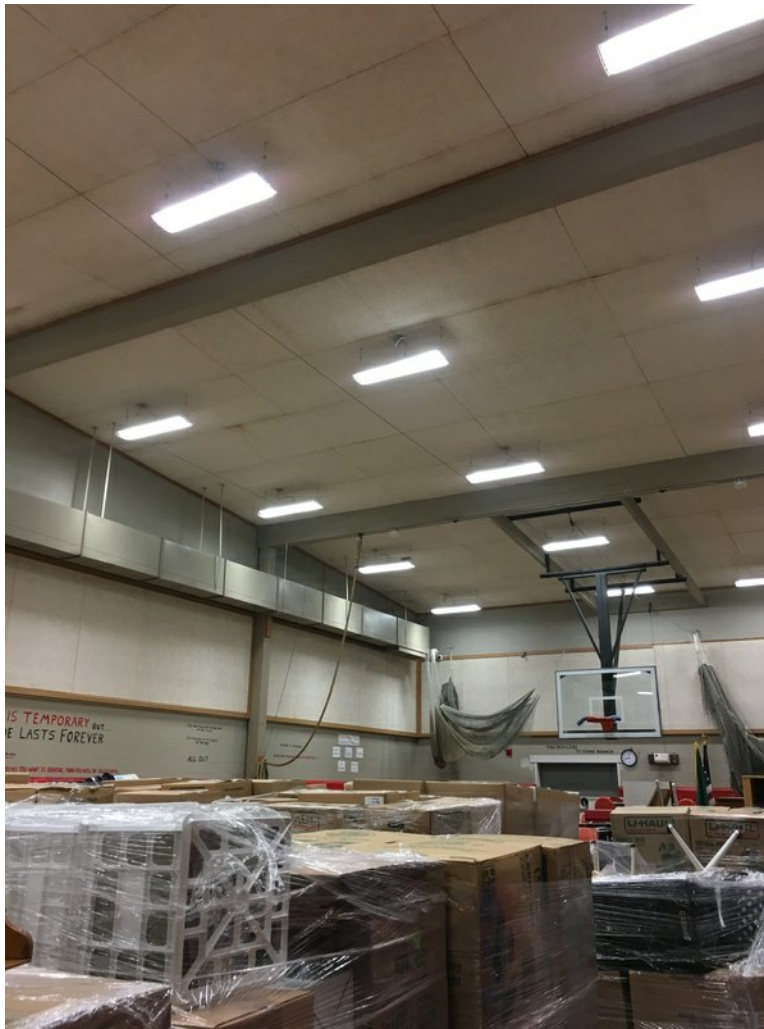
Figure 1-6. Gym/Shop Building, Roof Framing at Storage

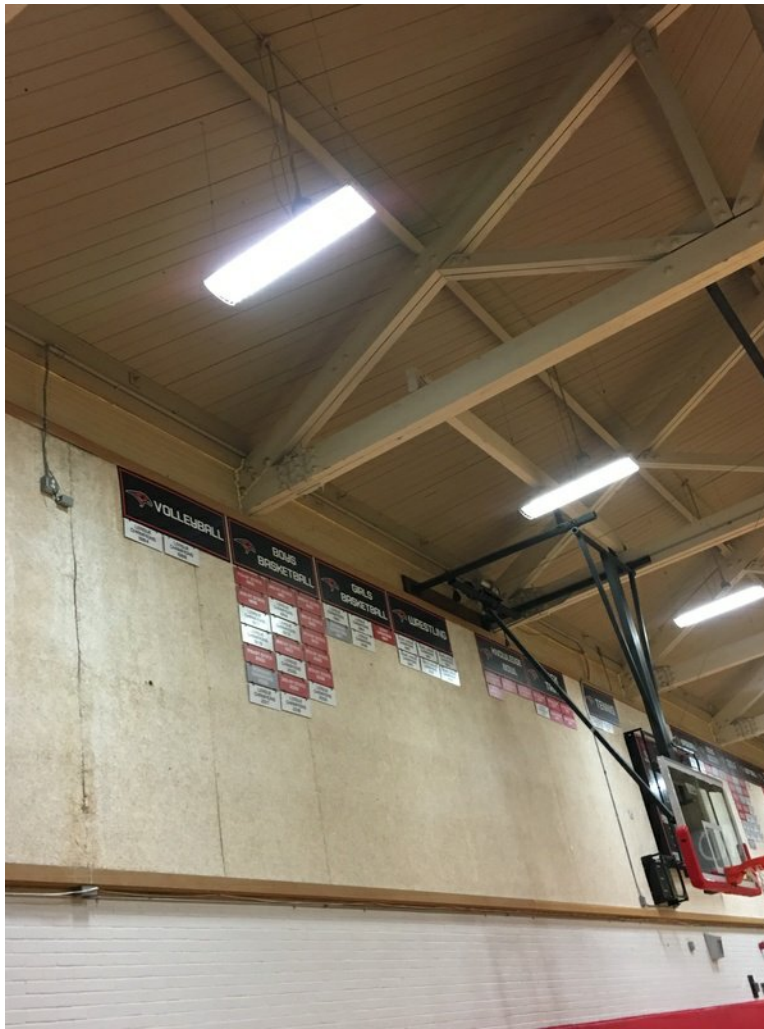
Figure 1-7. Gym/Shop Building, Typical Roof/Wall System

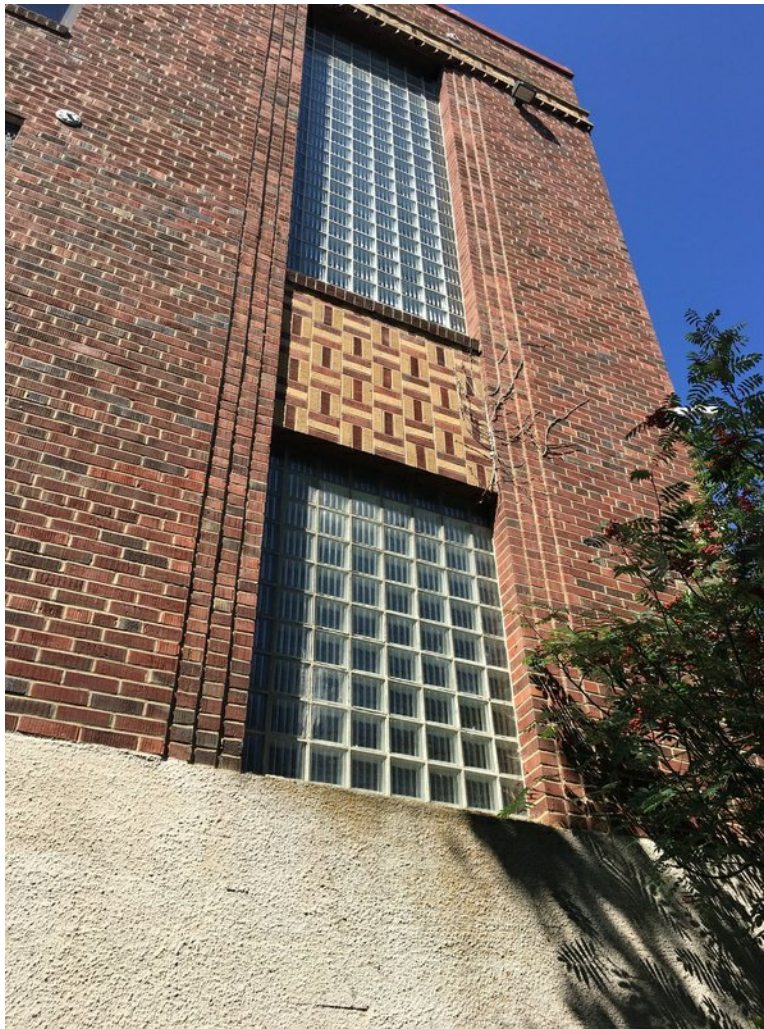
Figure 1-2. Main Building, Typical Exterior Wall System

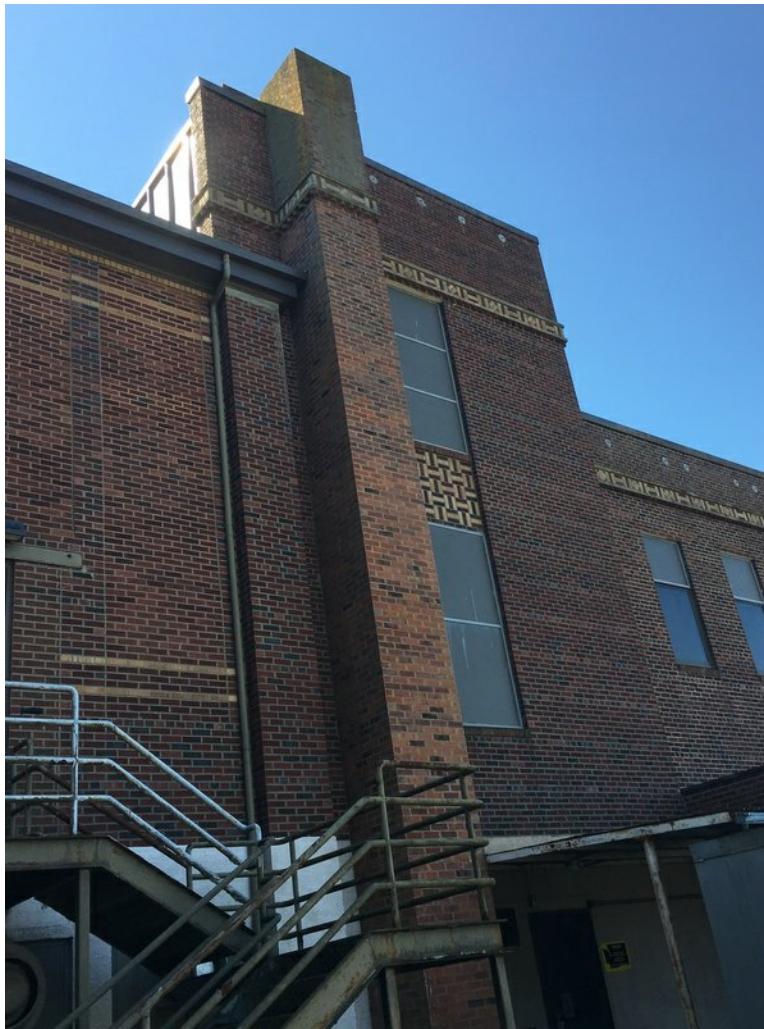
Figure 1-3. Main Building, North Wall

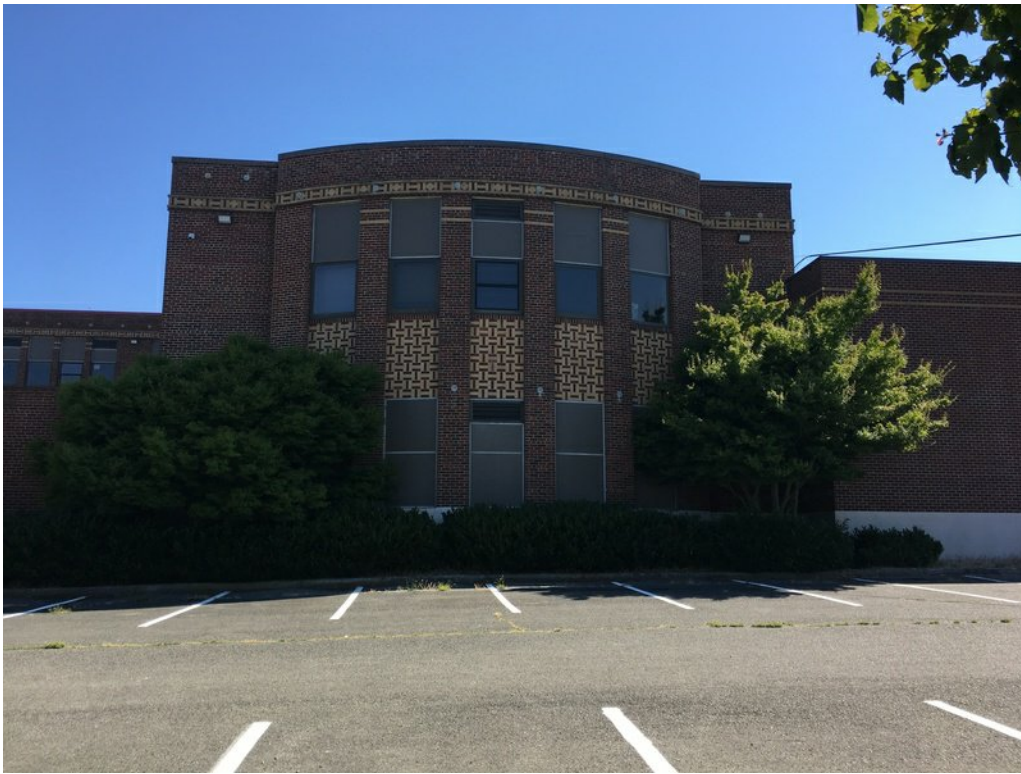
Figure 1-4. Main Building, Partial West Elevation

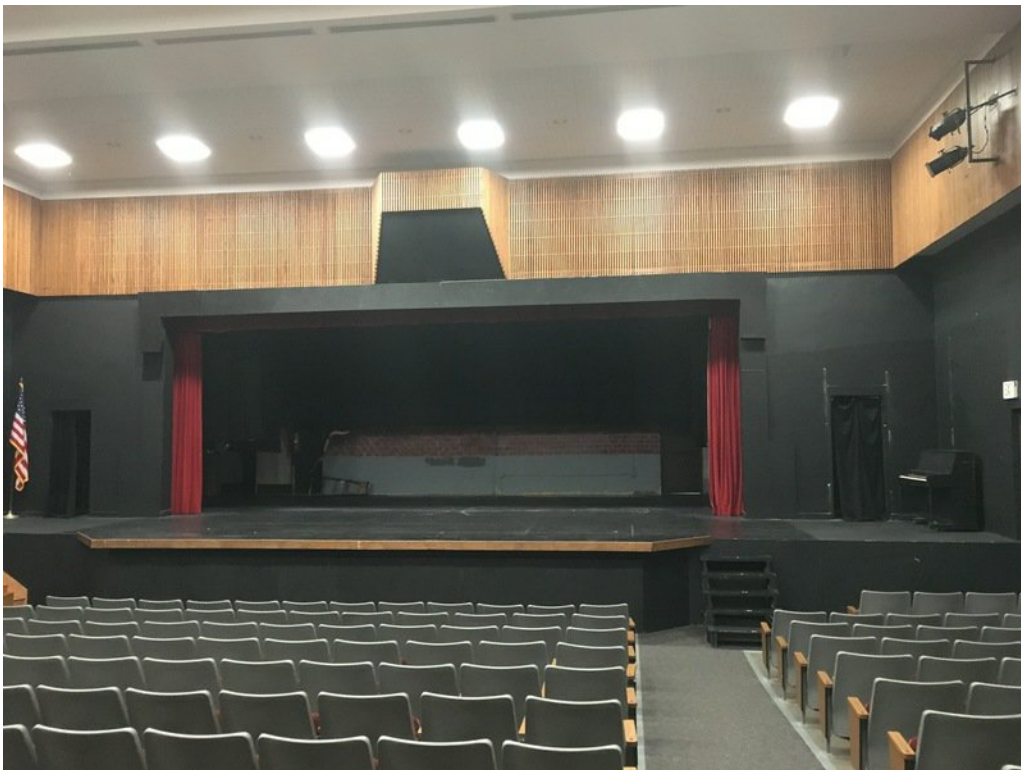
Figure 1-5. Main Building, Auditorium

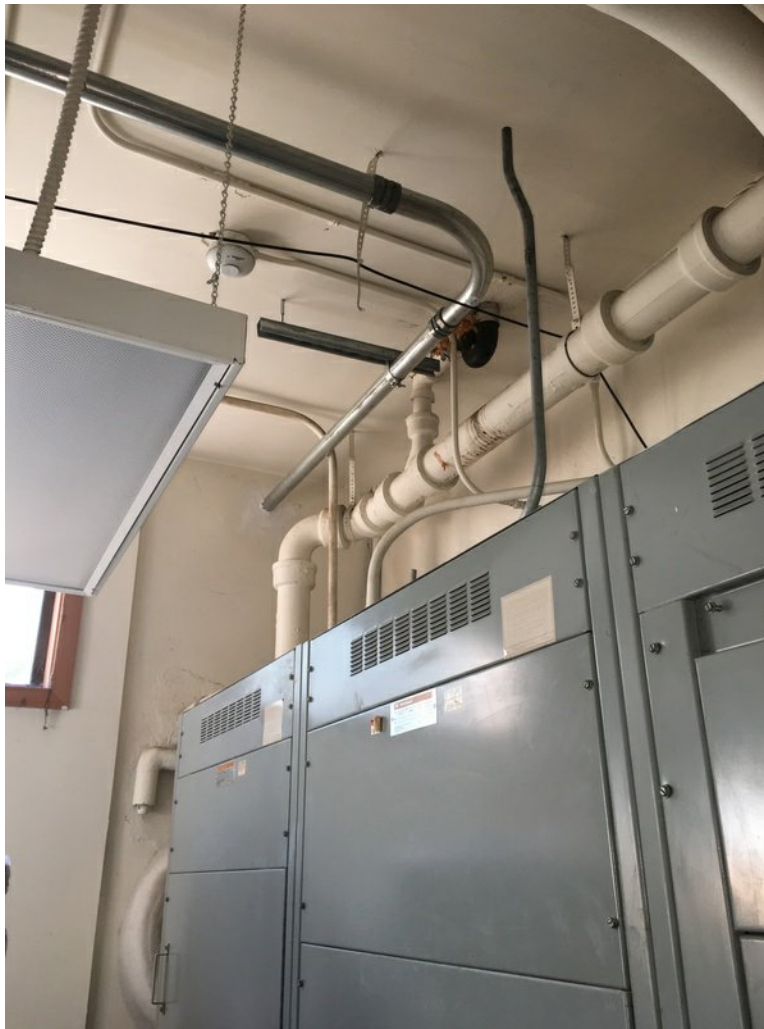
Figure 1-7. Main Building, Typical Electrical Equipment

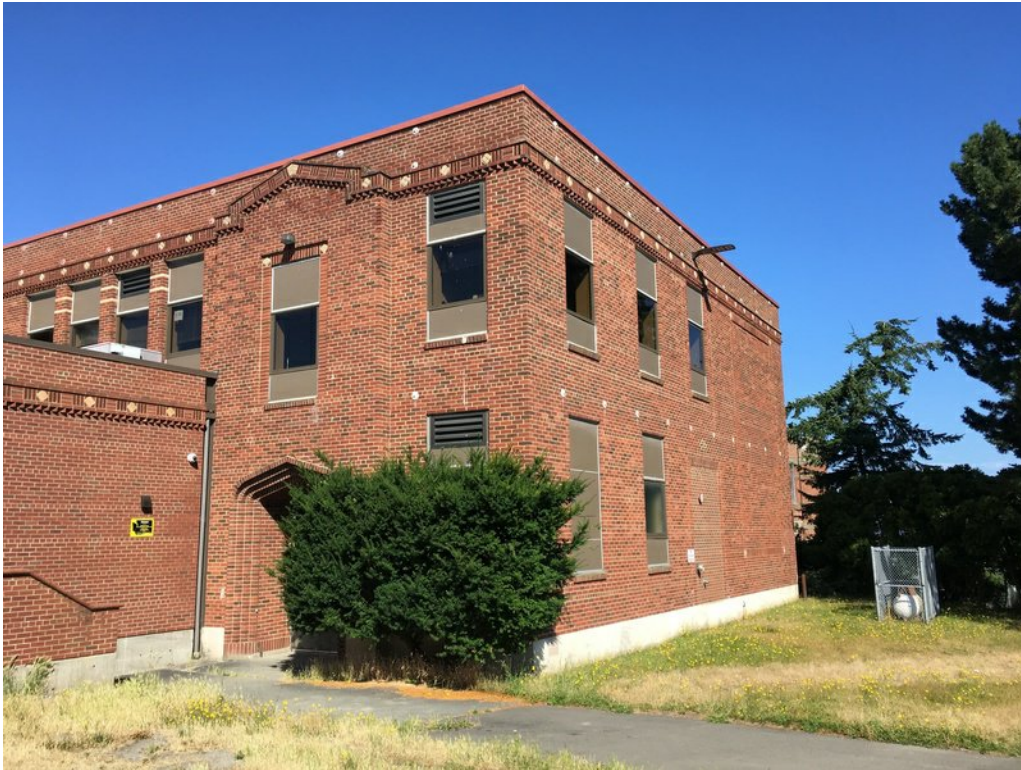
Figure 1-1. Math/Science Annex, Southeast Corner

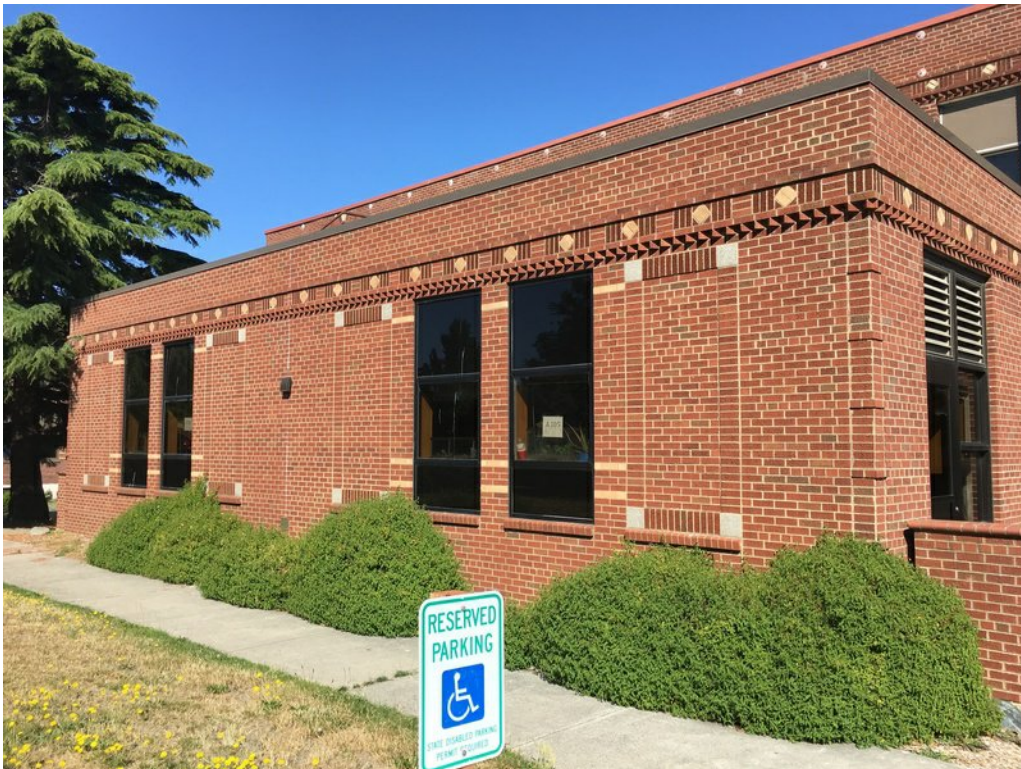
Figure 1-2. Math/Science Annex, South Elevation

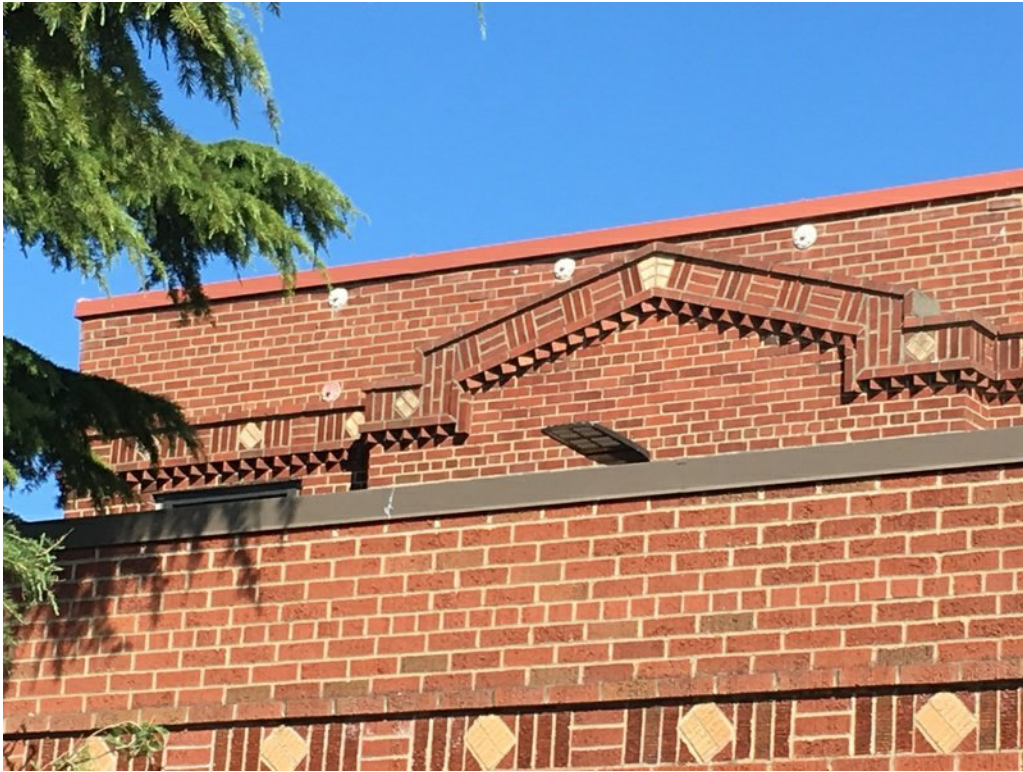
Figure 1-3. Math/Science Annex, South Elevation

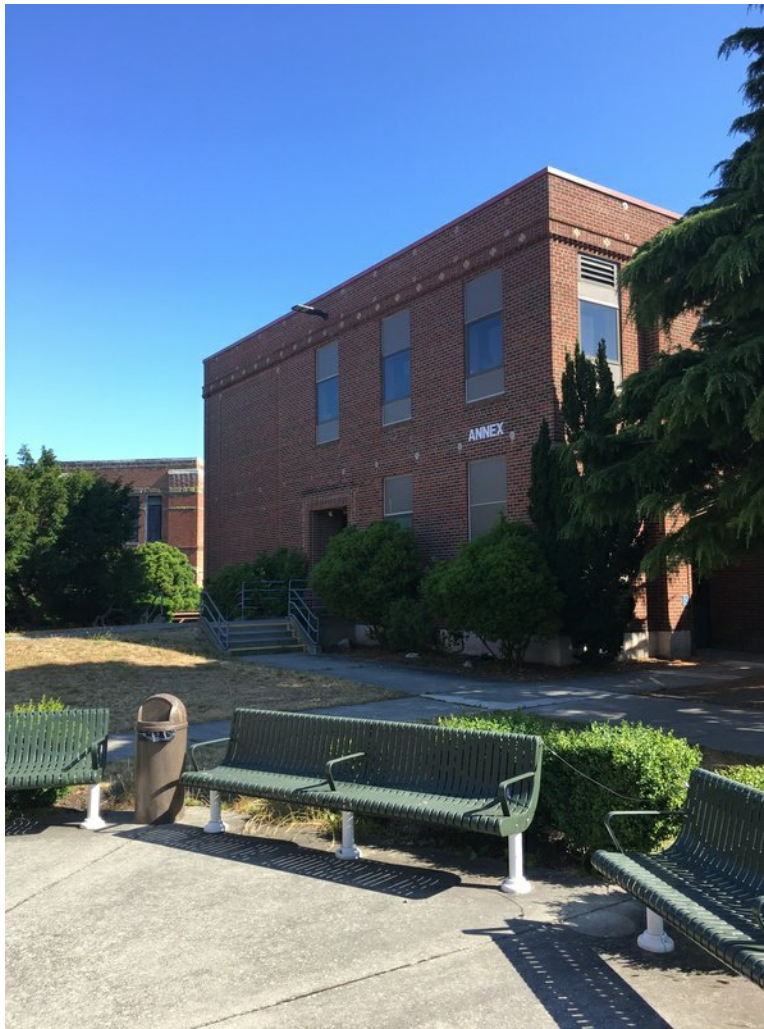
Figure 1-4. Math/Science Annex, West Elevation

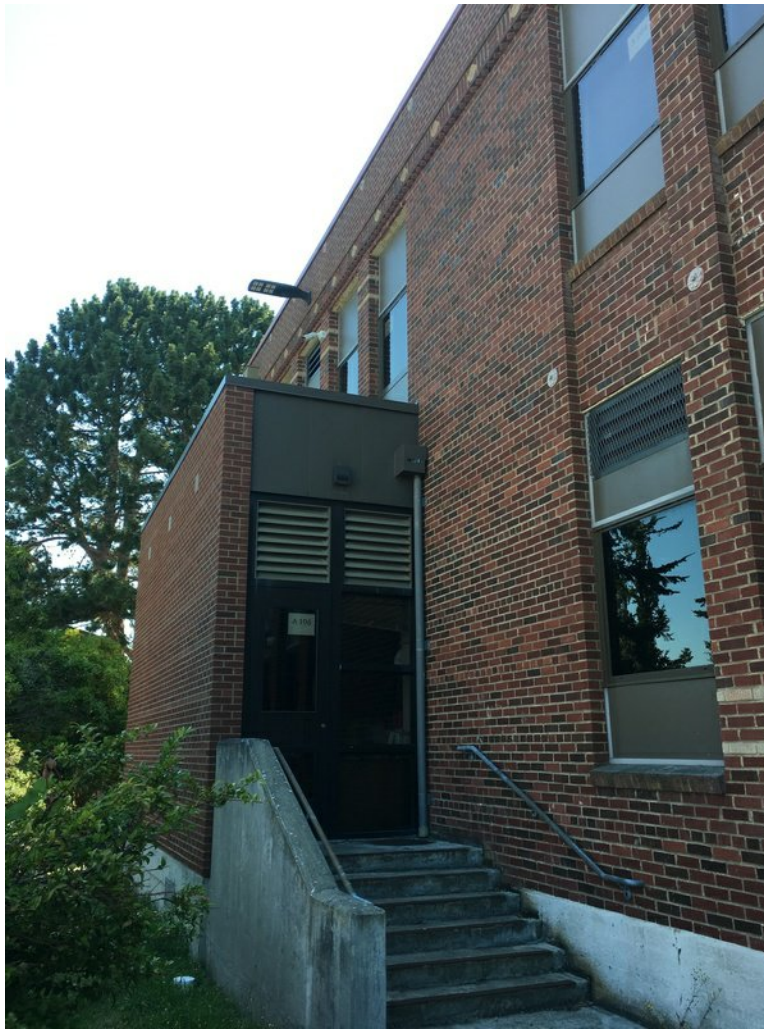
Figure 1-5. Math/Science Annex, North Entry

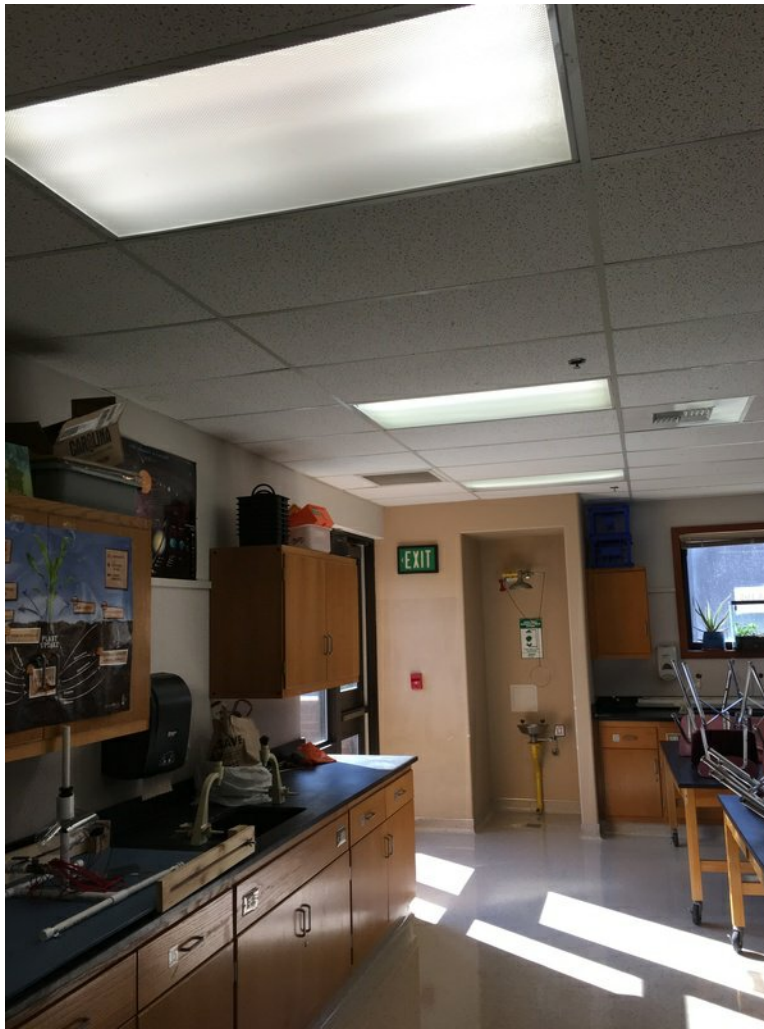
Figure 1-6. Math /Science Annex, Typical Ceiling System

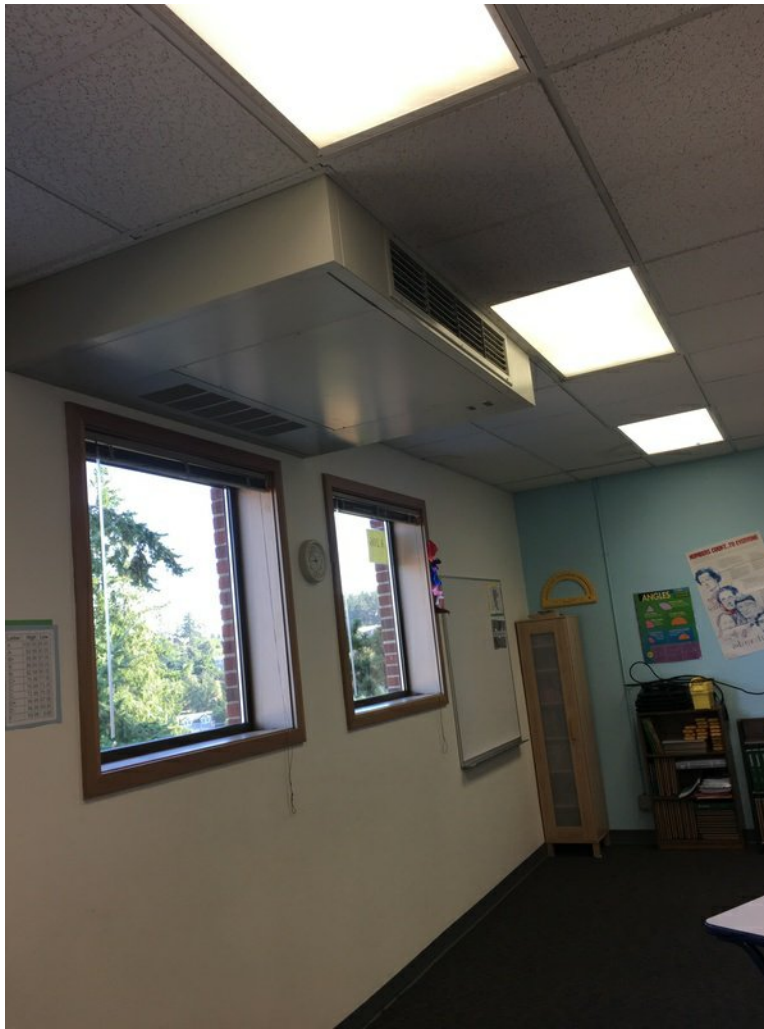
Figure 1-7. Math/Science Annex, Typical Window/Ceiling System

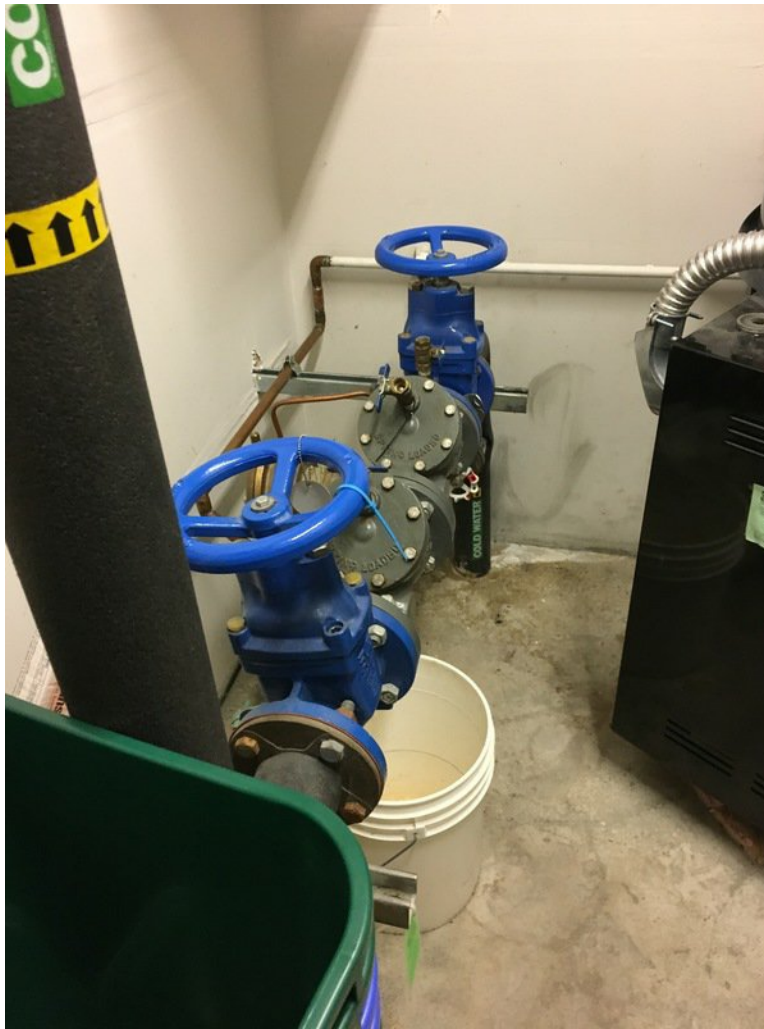
Figure 1-8. Math/Science Annex, Mechanical Room

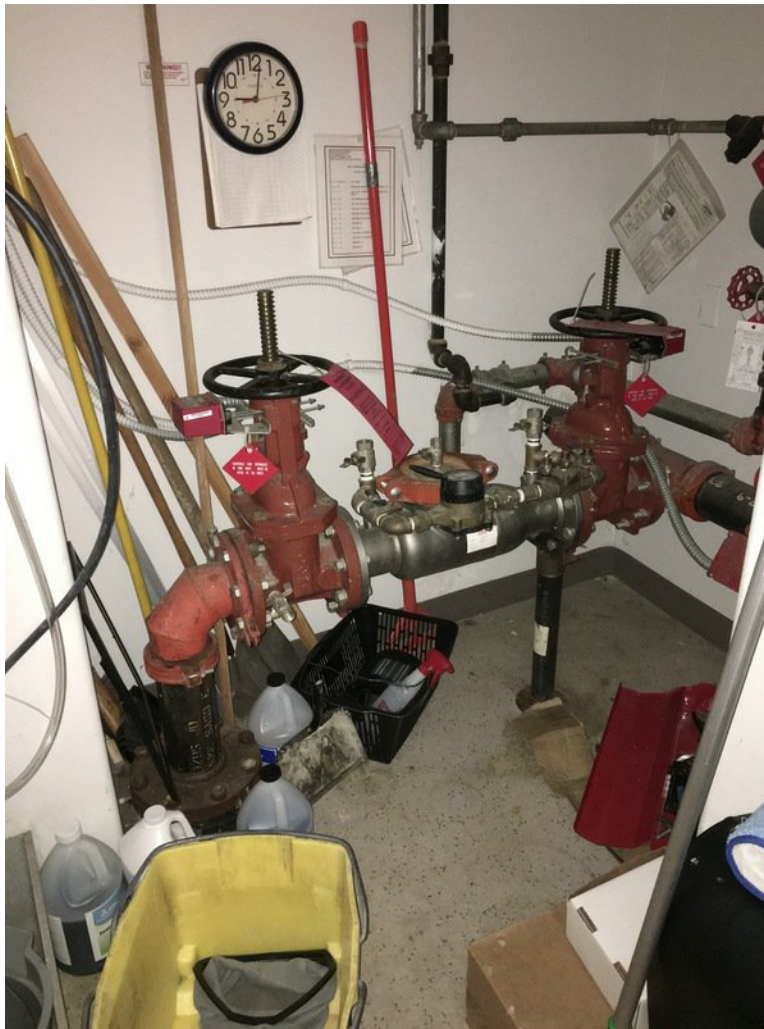
Figure 1-9. Math/Science Annex, Mechanical Room

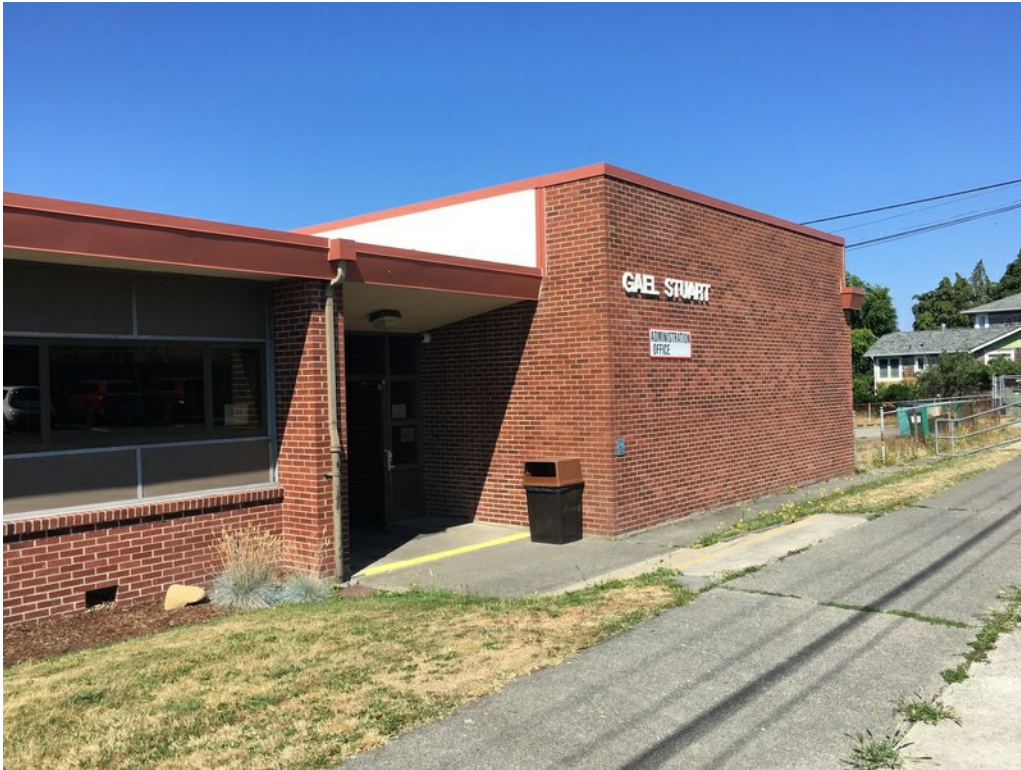
Figure 1-1. Stuart Building Entrance

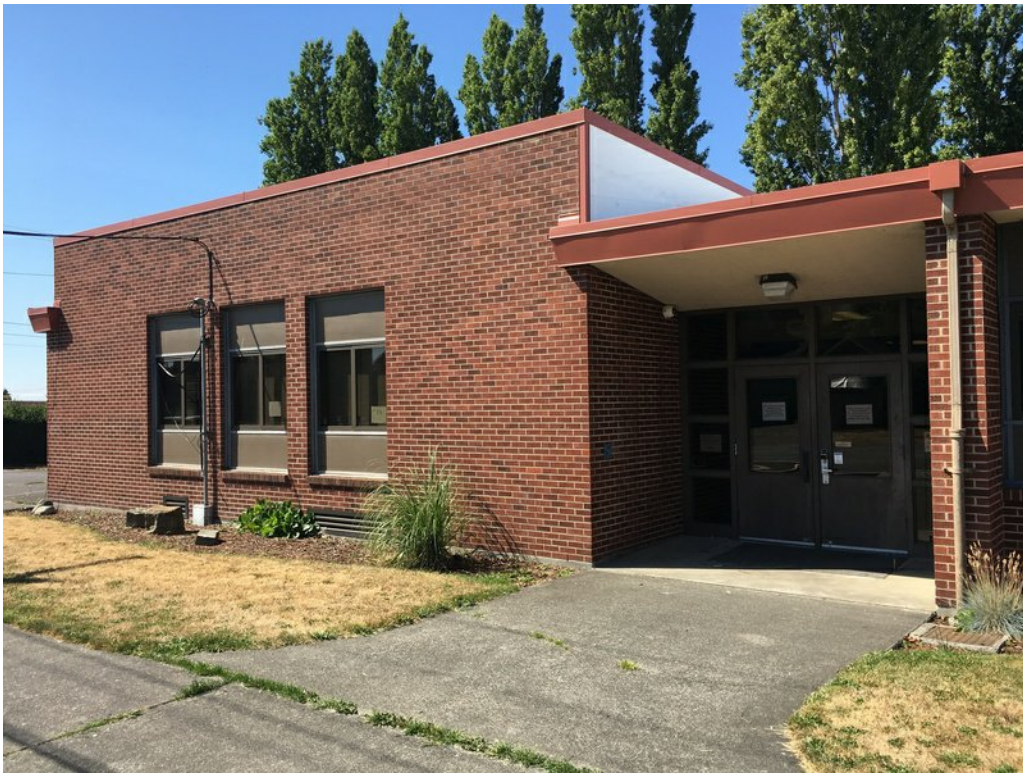
Figure 1-3. Stuart Building, South Entrance

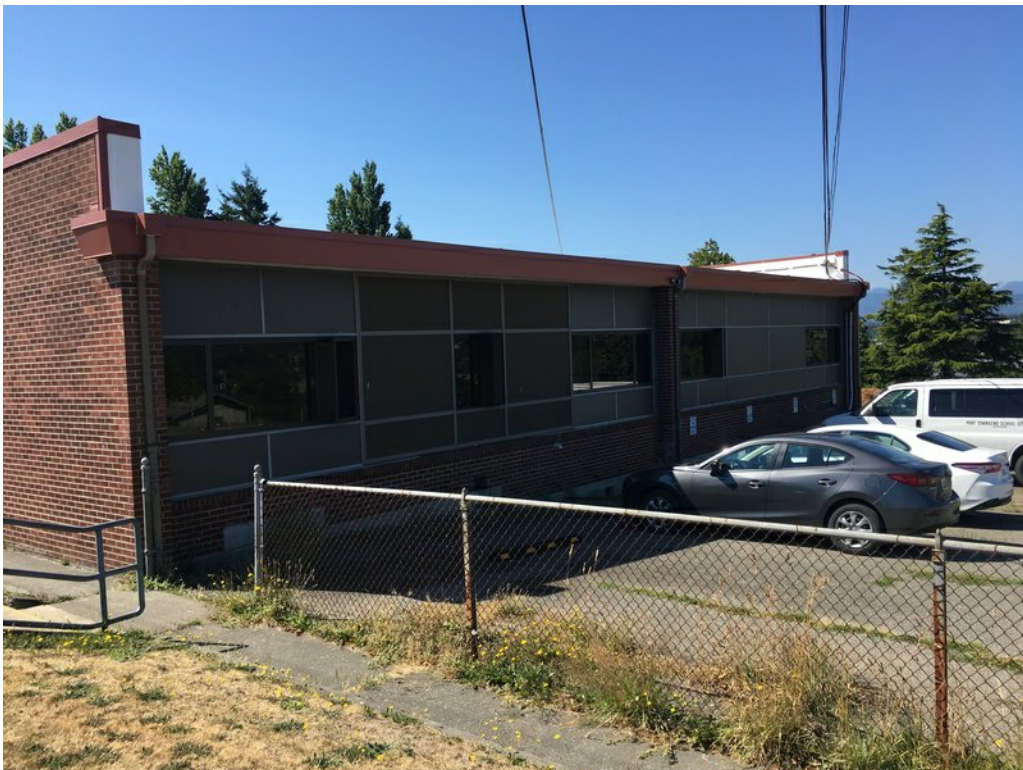
Figure 1-4. Stuart Building, North Elevation

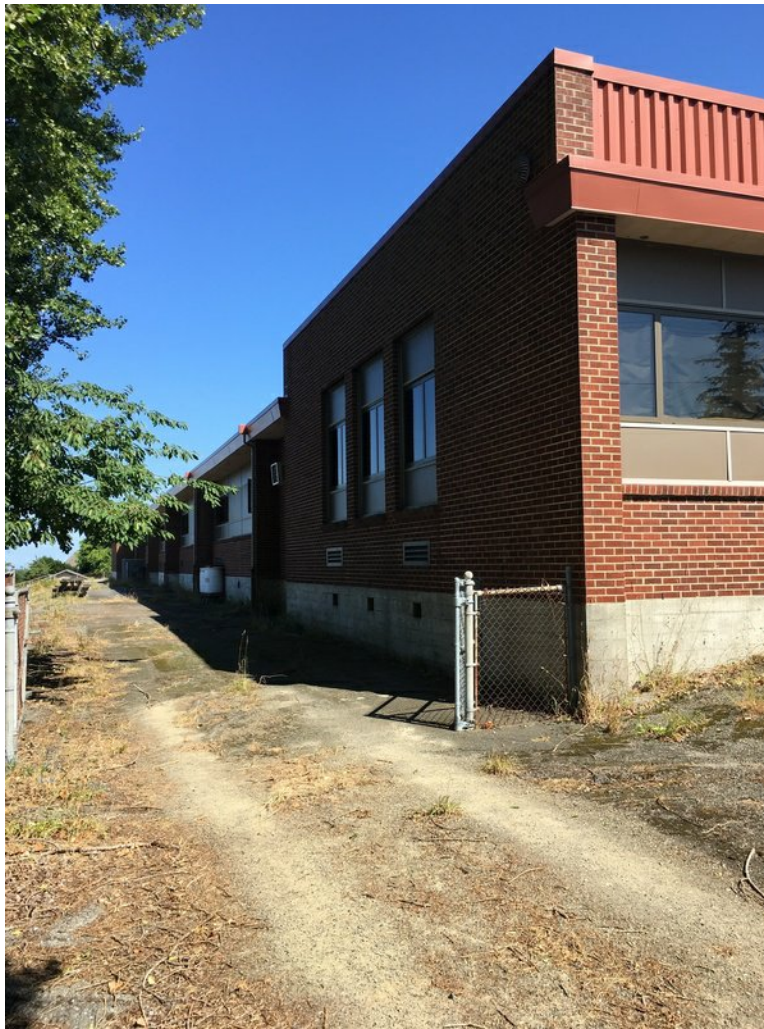
Figure 1-5. Stuart Building, Southwest Corner

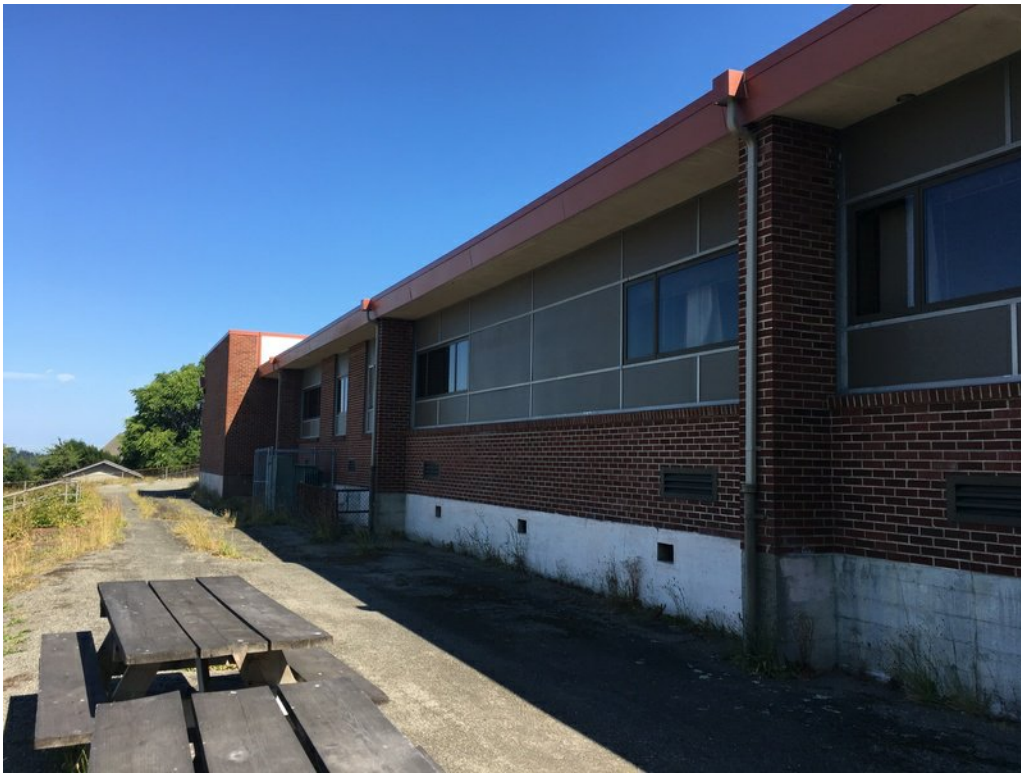
Figure 1-6. Stuart Building, West Elevation

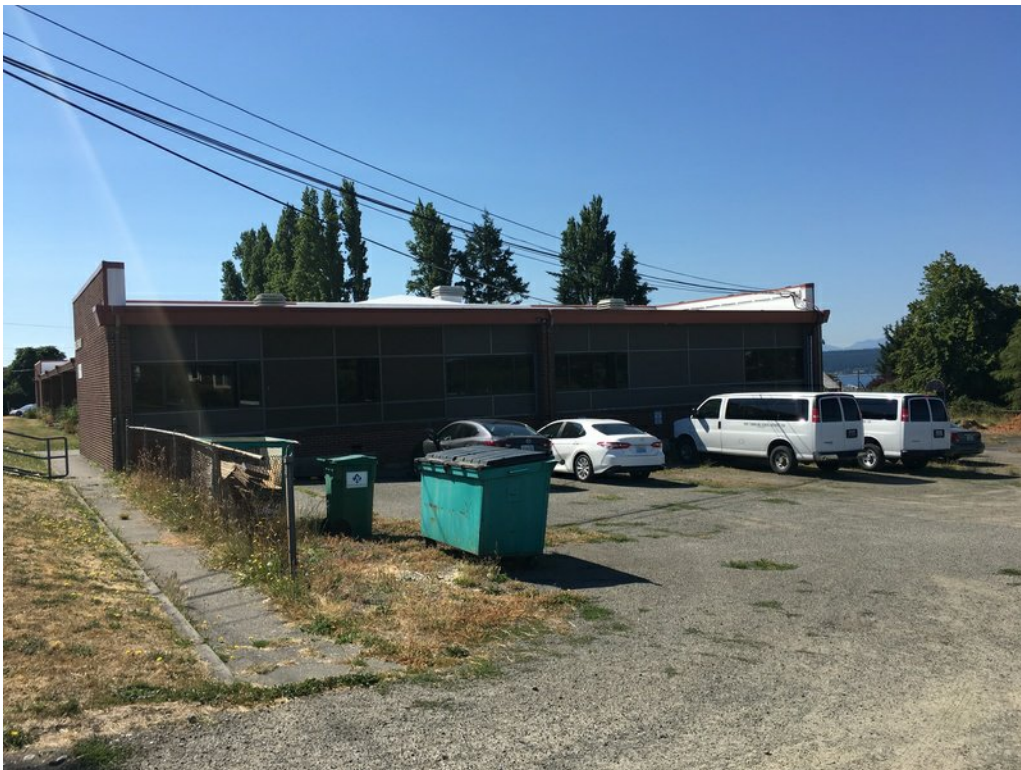
Figure 1-7. Stuart Building, North Elevation

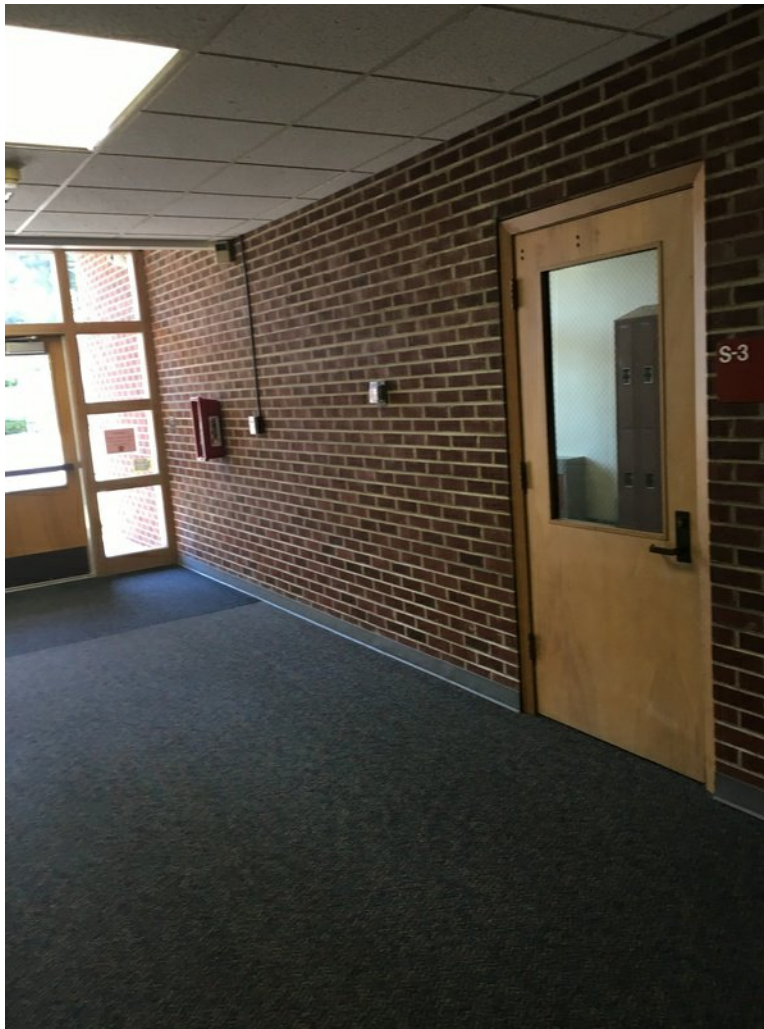
Figure 1-8. Stuart Building, Main Lobby

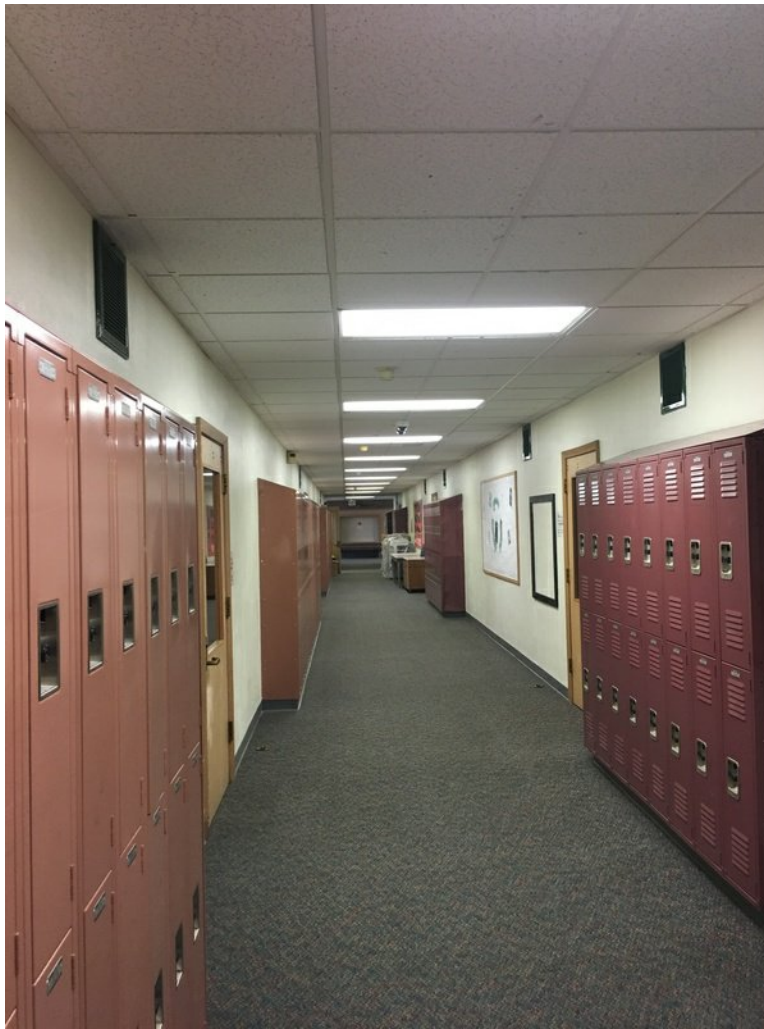
Figure 1-9. Stuart Building, Corridor
